Manhole Inspection Summary

Manhole # S01CC2001MH

Insp Date: **10/25/06 11:10 AM**

Location Address: **6321 PEARCE AVE**

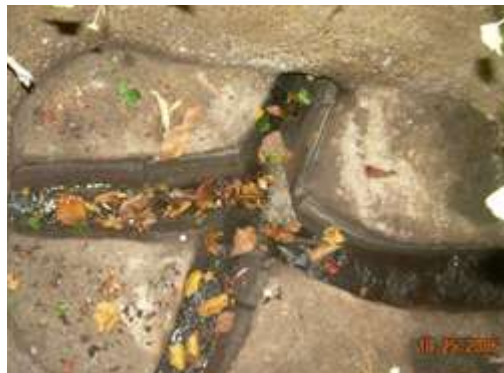
Top View

Evidence of surcharge - Bench debris.
Channel debris.

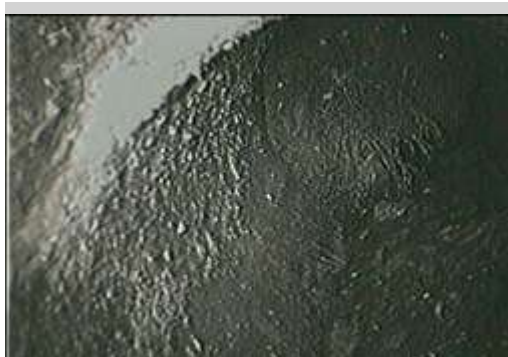
Inside the I6

Roots

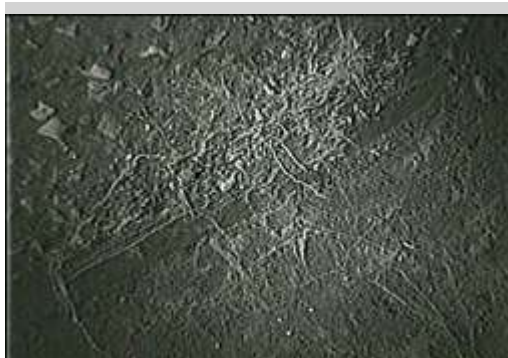
Defect

Condition: ☐ Sound ☐ Cracked ☒ **Root Intrusion** ☐ Loose Brick ☐ Deteriorated

Infiltration: ☐ None ☒ **Joint** ☐ Cracks ☐ Mortar ☒ **Roots** ☐ Wall

Corbel root intrusion and infiltration.

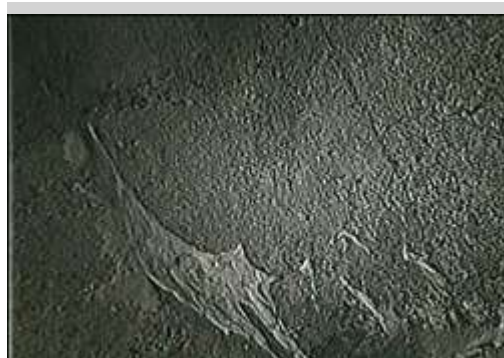
Defect

Condition: ☐ Sound ☐ Cracked ☐ Root Intrusion ☐ Loose Brick ☒ **Deteriorated**

Barrel deterioration and infiltration.
Evidence of surcharge.

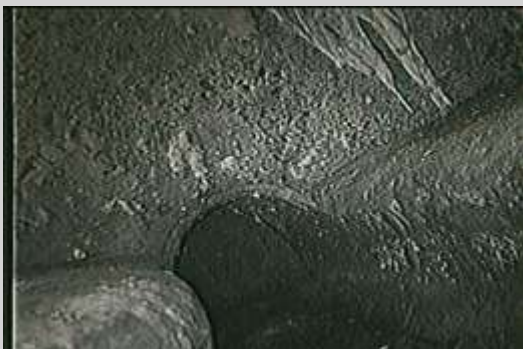
6 in. Circular Gravity Sewer Pipe In @ 3 O'Clock

Deposits: ☐ None ☒ **Mud** ☐ Sludge ☒ **Debris** ☐ Grease

Silt Depth: **1** (in.) Deposits Extent: **Light**

Infiltration: **None** Pipe Seal Cond: **Cracked**

Connects To: **Stub connection / abandoned**

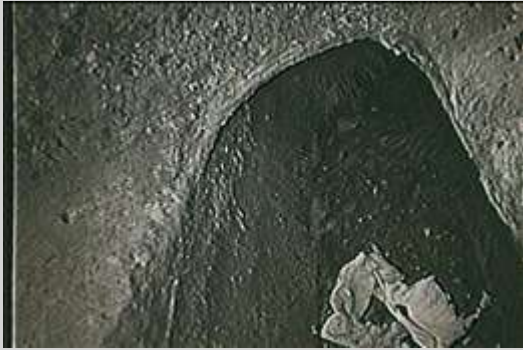
Pipe In @ 6 O'Clock

Deposits: ☐ None ☒ **Mud** ☐ Sludge ☒ **Debris** ☐ Grease

Silt Depth: **1** (in.) Deposits Extent: **Light**

Connects To: **Stub connection / abandoned**
